# PITTING CORROSION OF 304 STAINLESS STEEL IN AN ACTIVATED CARBON FILTER

## CORROSÃO POR PICADA DE UM AÇO INOXIDÁVEL 304 NUM FILTRO DE CARVÃO ACTIVADO

Water leakages of an orange color were found in the cross welding zone and barrel of an activated carbon filter used in a wastewater treatment plant. The analysis of the chloride content in the plant flowsheet showed that the equipment was subjected to unsuited chloride concentration for 304 stainless steel resistance to pitting corrosion. The inside shows holes distributed randomly from about 20 cm above the welding zone to the lower outlet port of the equipment.

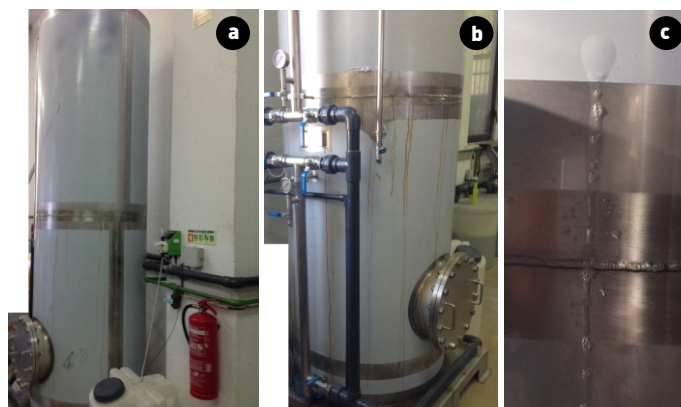
**Fig. 1** - Activated carbon filter.

It is an activated carbon filter used in the installation of wastewater treatment of a cosmetic industry, Fig. 1a), showing leakages in the region of circumferential weld seam, Fig. 1b), and under the plastic coating to protect the equipment against scratches on shipping, Fig. 1c).

- a)** Equipment: h = 2.80 m, D = 0.90 m, e = 2 mm (body) and 2.5 mm (top and bottom); material, stainless steel 304;  
**b)** Leakages with orange color in the welding zone;  
**c)** Bubble with leakages under the plastic lining.

- The device is coated with plastic on the cylindrical portion except the area adjacent to the circumferential weld bead, Fig. 1a).
- The water leakages of orange color on the cylindrical body emanate from the welding bead, Fig. 1b) and Fig. 2a), and from non-visible holes under the plastic, Fig.1c) and Fig. 2b).
- The plastic removal in zone 30 cm from the bottom outlet of the equipment showed several perforations originating from the inside to the outside.
- Pits have a variable size from 0.7 to 2.5 mm, and tend to aggregation.
- Control valves do not show the presence of pits.

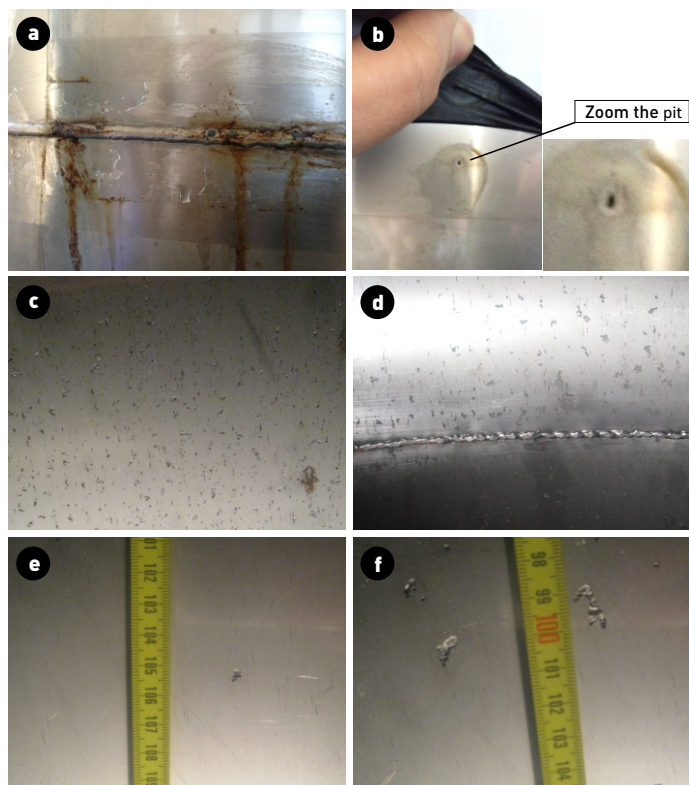
**Fig. 2 - a)** Detail of the weld zone; **b)** Hole under the plastic; **c)** Area inside the filter below the welding; **d)** Area in the vicinity of the circumferential weld seam; **e)** and **f)** Inside areas below the welding with a reference scale.

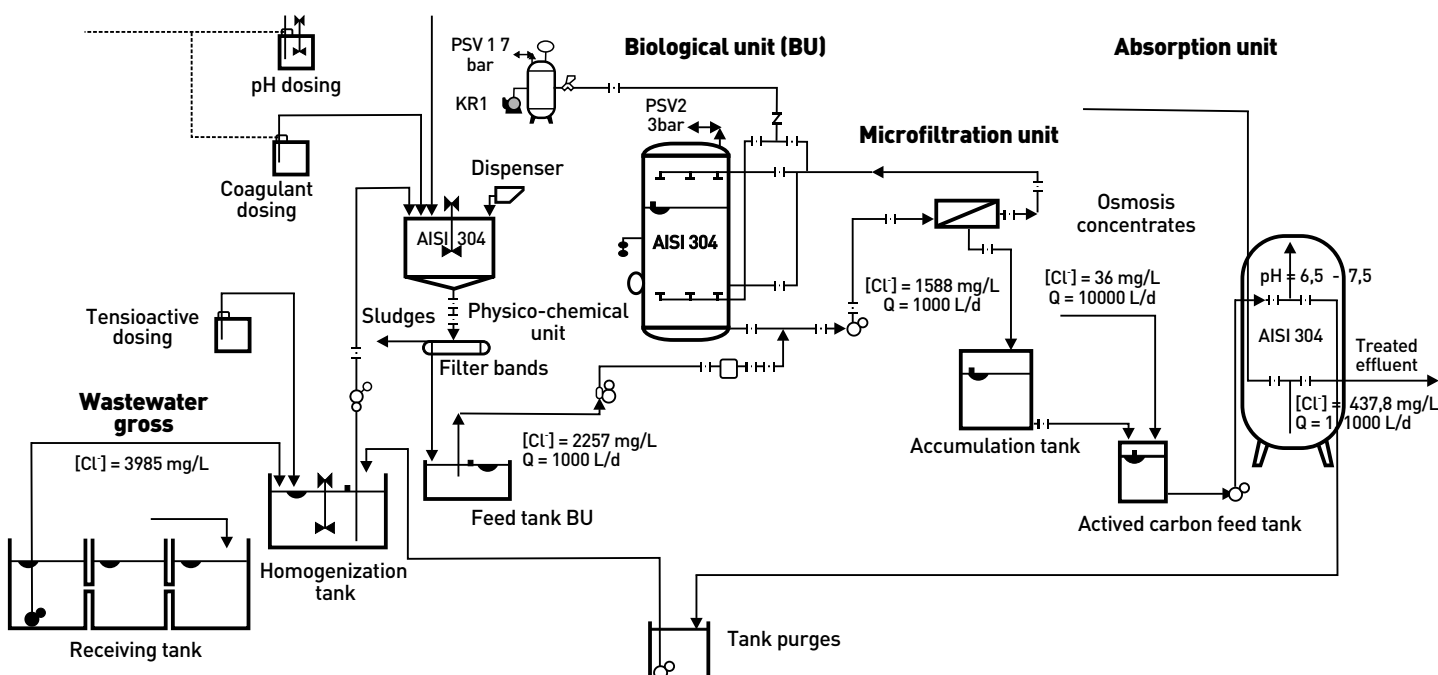
**Fig. 3 - Flowsheet of the wastewater treatment.**

Fig. 3 shows the processing wastewater plant diagram with the flow rates and the respective composition of chlorides. The information set on flowsheet show the following:

- The chlorides are present in the raw wastewater and consequently their concentration is not increased significantly from the primary antifoam coagulant used in the physico-chemical unit to promote flocculation.

- It is added to the effluent treatment plant, before adsorption unit, a flow of 10,000 L d<sup>-1</sup> with a chloride concentration of 36 mg L<sup>-1</sup> from a factory osmosis unit that uses the public water previously dechlorinated and decalcified for protecting the osmosis polymeric membrane.

- The incoming flow in the adsorption unit is 11,000 L d<sup>-1</sup> with 177.1 mg L<sup>-1</sup> chloride content.
- Microfiltration unit periodically needs to promote the cleansing of the ceramic membrane with a closed loop system using the following operative sequence: 1) washing with water; 2) cleaning with an alkaline solution of sodium hydroxide (0.5 %) and sodium hypochlorite (2,000 ppm); 3) washing with water; 4) washing with citric acid solution; 5) washing with water. Thus, from time to time it is introduced into the treated water storage tank, an effluent with residual chlorine (not determined) from the remaining hypochlorite.

- The hypochlorite handling for the recovery of ceramic membrane is in the vicinity of the activated carbon adsorption unit, wherein the storage tank sewage drains by gravity to the hand-tight tank feeding the adsorption unit.

The equation (1) shows that [Cl]<sub>s</sub> = 4,028 ppm, which means a passage of chloride ions from activated carbon to the effluent. Thus, the interior of the equipment has been subjected to a high chloride concentration at neutral pH and room temperature.

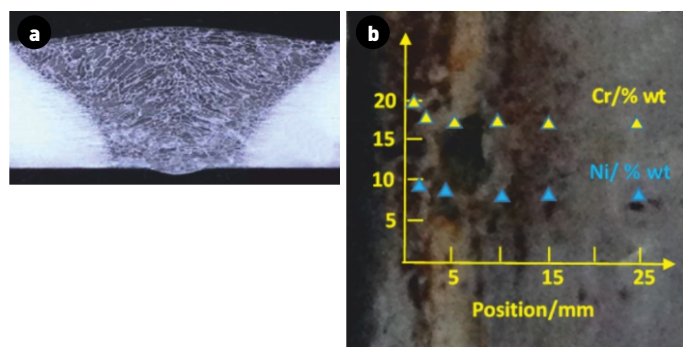
The radiographs in the welding zone of the equipment, Fig. 5 a), show a good penetration and uniform bead, even in the place where holes have been observed. As holes were found in areas outside the welding zone we must conclude that the material failure is not due to welding, but instead to the high aggressiveness of the environment for the steel alloy in question.

The chemical analysis performed from the fusion zone until the parent metal, Fig. 5, shows a chromium content according to passivation.

The chromium content ranges from about 19.0 % in the fusion zone to 18.3 %, and nickel from 8.7 % to 8.0 %.

Fig. 5 - Welding area. a) Macrograph; b) Chromium and nickel content from fusion zone to parent metal.

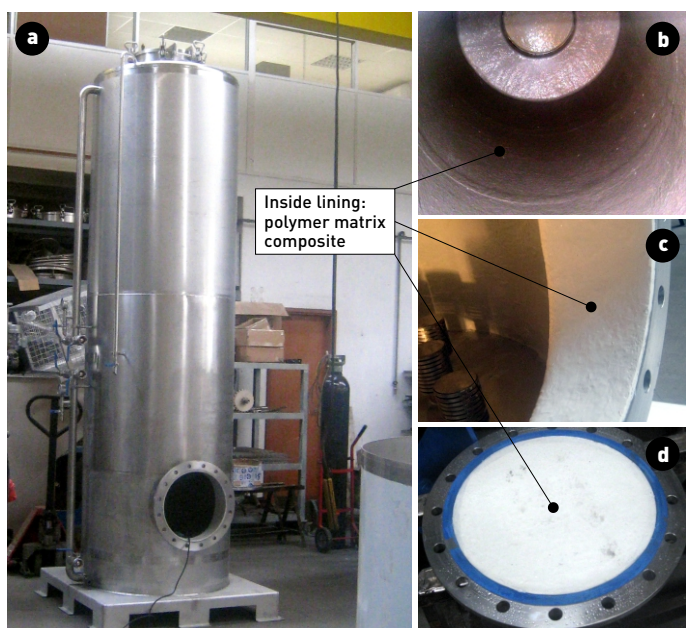
**Fig. 6** - Activated carbon filter. **a)** Equipment after repair; **b)** Top interior view; **c)** Bottom interior view; **d)** Flange.

- 1 - Eliminate chlorine in the input stream of the filter unit coming from the ceramic membrane cleaning. The discharge of the downstream effluent must be made to a tank containing a reducing agent (e.g., sodium bisulfite) for limiting the residual chlorine content to 0.01 ppm before entering the public network.
- 2 - Remove the plastic coating, which is only performed for protection of the equipment during road or railway transport.
- 3 - Control the chloride content in the input stream and output of adsorption unit to set the breakthrough of chlorides suitable to avoid the inversion of the adsorption mechanism of the activated carbon.
- 4 - Avoiding the stainless steel 304 contact with the effluent proceeding to its coating with a polymer (polyester) matrix composite, Fig. 6. In this mode the stainless steel only provides the mechanical properties.
