# STEEL FASTENERS FAILURE BY HYDROGEN EMBRITTLEMENT

M. TERESA FERRAZ, MANUELA OLIVEIRA \*

INETI-DMTP, LCM – Laboratório de Caracterização de Materiais, Estrada do Paço do Lumiar, 1649-038 Lisboa  
teresa.ferraz@ineti.pt

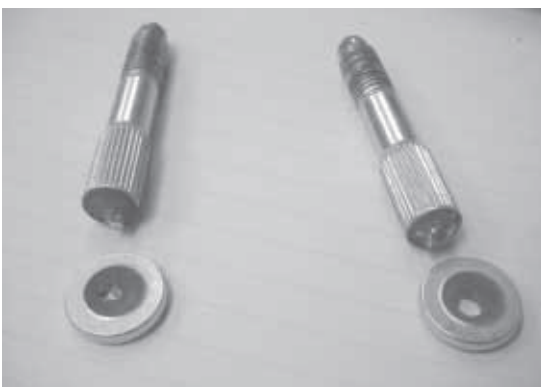
**Fig. 1.** General view of two fractured bolts

- All bolts failed in a similar way;
- fractured surfaces were similar and the rupture had occurred apparently without necking (plastic

deformation) in the transition zone between head and shank;

- there was no general oxidation and/or corrosion;
- fracture surfaces were quite smooth and normal to the direction of the applied loads, except for the central part corresponding to the end of fracture;
- fractures seemed to have had its origin all around the circular external bolt surface, where several initiating zones were observed.

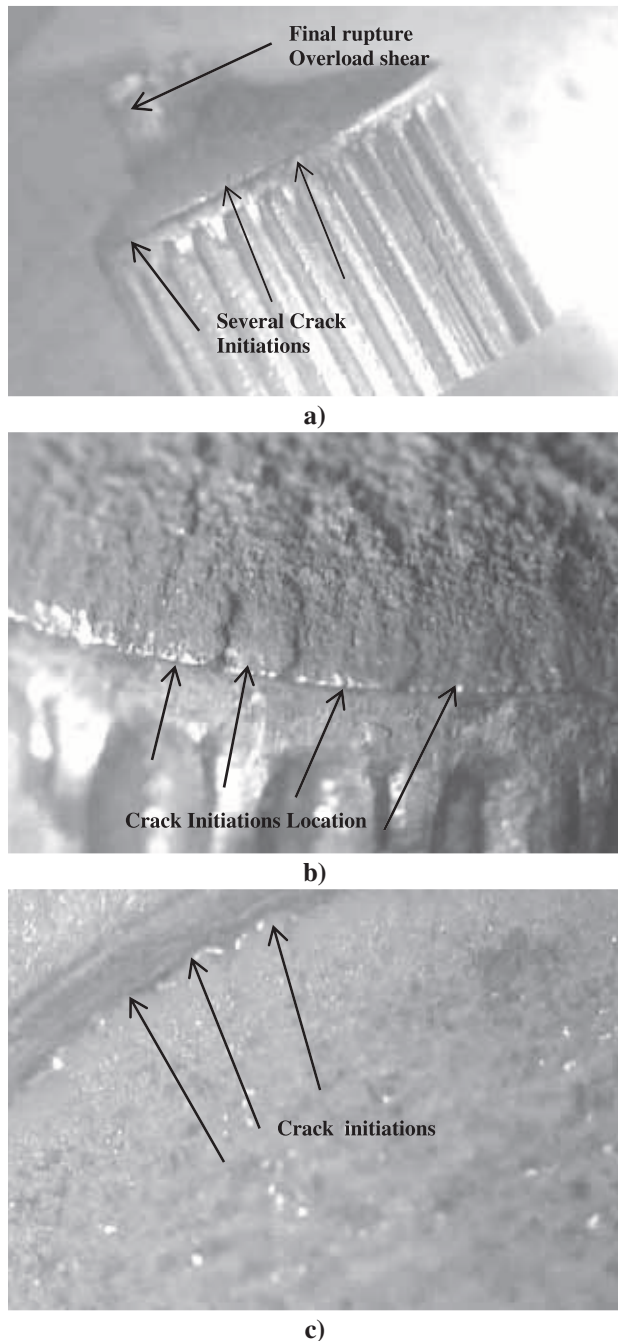
Observations at low magnification (Fig. 2) showed that:

- Fracture characteristics were similar in both bolts indicating that failure must have occurred by the same causes;
- the fractures were almost parallel to the cross section, and occurred with no evidence of deformation or distortion near the origin;

- the fracture surfaces were nearly flat with several crack initiation zones all around the external bolt surface;
- origins were located at slightly different levels and after a short propagation cracks joined together in a common front;

- the fracture surface area corresponding to this first stage of propagation showed the smoothest surface on fig. 2 b) and 2 c);
- cracks continued to propagate towards the centre, and fracture surfaces became rougher;

- final rupture occurred by overload shear and showed a change in crack propagation direction towards the top of the bolt head;
- both fractures occurred almost instantaneously after cracking initiation due to the applied stresses.

**Fig. 2.** Fractured bolt: a) General side view of fracture surface, shank side; b) details of fracture initiation zones at head-shank transition surface, shank side; c) details of fracture initiation zones at head-shank transition surface, head side.

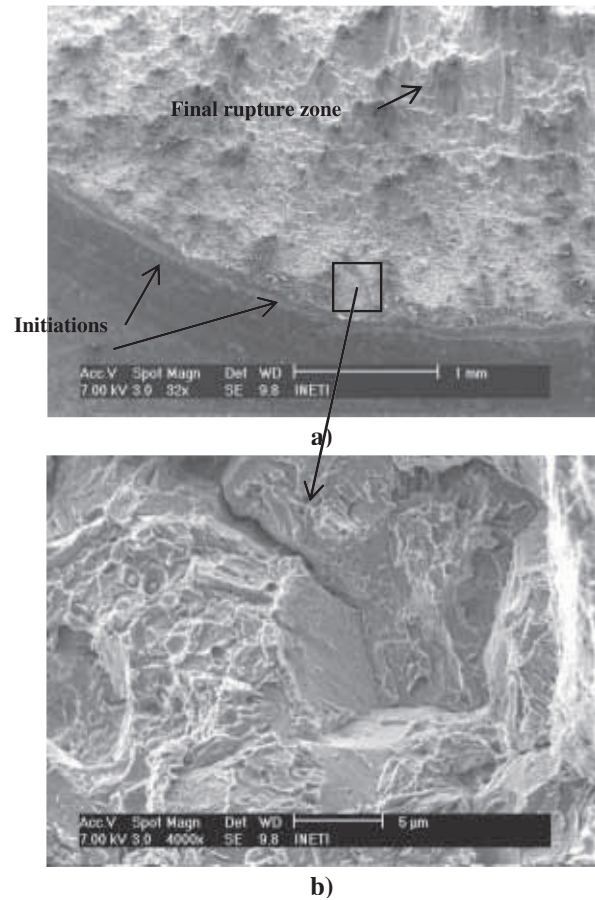
- Cracking initiation zones and zones near the surface presented both intergranular and transgranular crack propagation;
- crack growth zones showing intergranular features also presented intercrystalline subsidiary cracking (or yawning grain boundaries), and micro-pores and ductile hair lines, often branched forming crow feet marks, at prior austenite grain boundaries [6];
- intergranular fracture surfaces zones showed some small areas, looking like nests, where intercrystalline

characteristics are more pronounced as grains seemed more individualized;

**Fig. 3.** SEM observation of one of the bolts fracture surfaces: a) overall view of initiation zones near shank external surface; b) detail from marked area, fracture propagation partially intercrystalline and transcrystalline, intergranular zones showing intercrystalline subsidiary cracking, micro-pores and ductile hair lines at the former austenite grain boundaries.

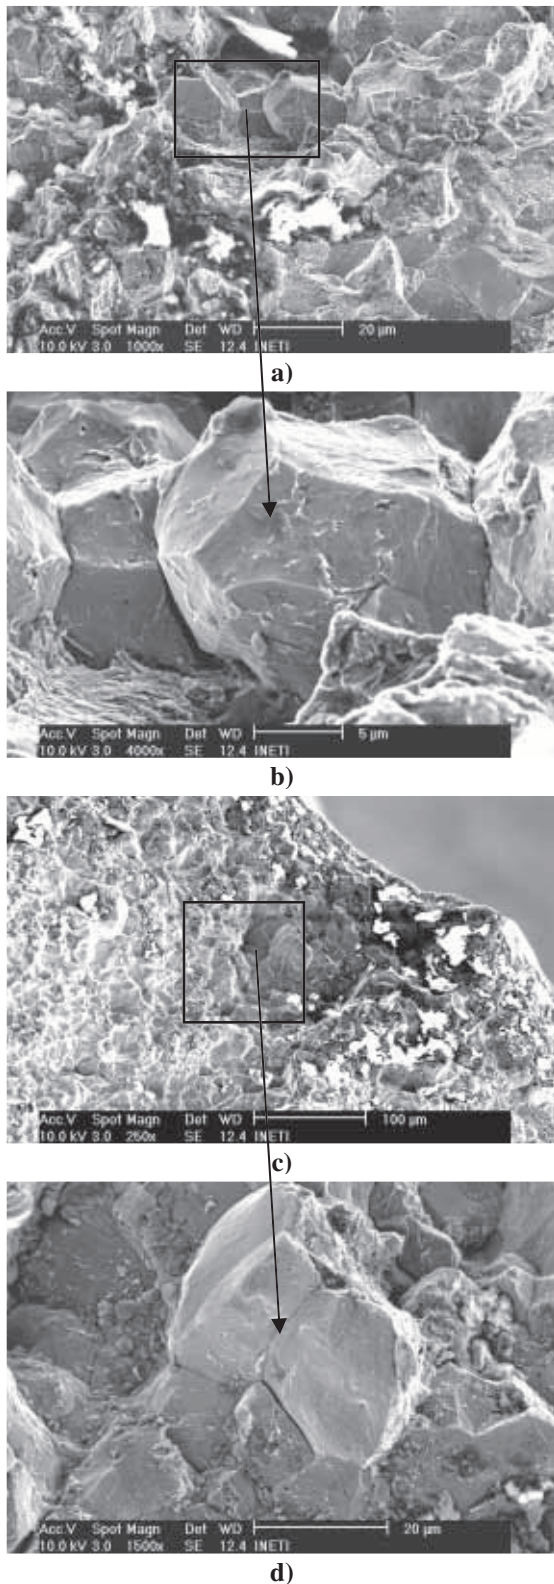
**Fig. 4.** SEM observation of the other bolt fracture surfaces: a) and c) general view at the initiation zone near the external surface of the shank; b) and d) details from marked zones with pronounced intercrystalline characteristics showing grain surface features like micro-pores and ductile hair lines at the former austenite grain boundaries.

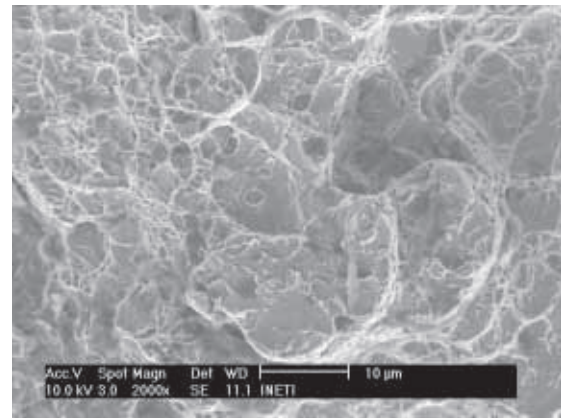
- at the end of the propagation failure process, close to the centre of the bolts, the fracture surface showed a typical dimpled configuration with elongated cavities (fig. 5);

**Fig. 5.** SEM observation of fractured surfaces: dimpled rupture fracture surface at final rupture zone near bolt centre

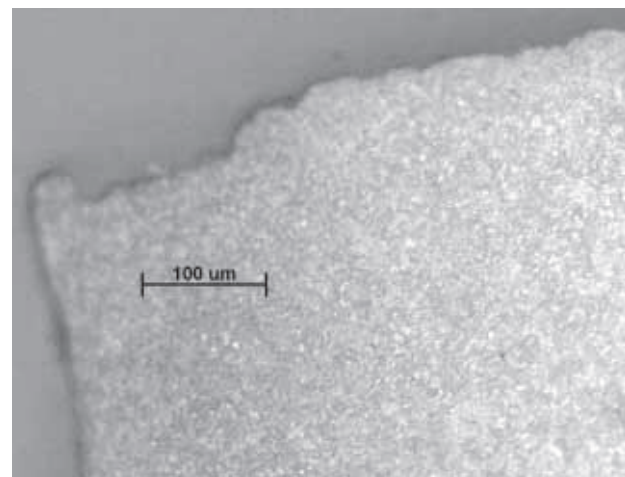
Metallographic examination of the longitudinal sections from the head and the shank showed the typical microstructure of hardened and tempered steel, with no visible external surface decarburization (Fig. 6) or continuous carbide precipitation along grain boundaries (Fig. 7).

**Fig. 6.** Metallography of the shank cross section: external surface and initiation of fracture zone from the fracture surface

At the initiation zone, fracture surface was flat and rather smooth and there was no fracture branching neither oxides deposits nor decarburization over the fracture surface. Some small intercrystalline subsidiary cracking was detected on fracture surface grains.

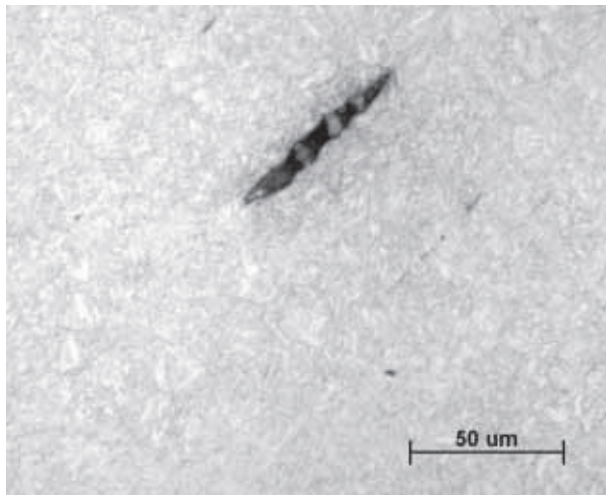
Few non-metallic inclusions appeared cracked or debonded from the matrix, indicating lack of ductility. Fig. 7 exemplifies one agglomerate of inclusions, cracked and debonded from the matrix, and seeming to originate a micro-crack, almost 50 µm long, with rather sharp tips.

**Fig. 7.** Metallography of the shank cross section just below fracture surface: sulphide and oxide non metallic inclusions and a set of cracked and/ or debonded inclusions, resulting into a micro crack.

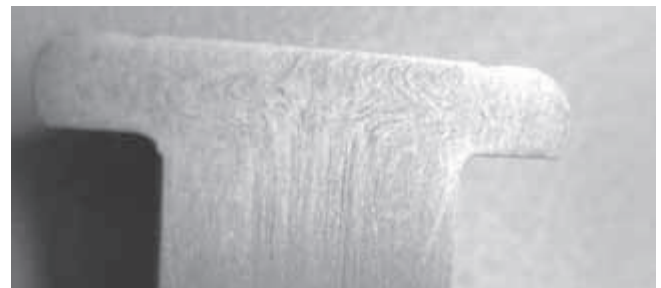
Bolts manufacturing process can produce highly non-uniform deformation, as shown in Fig. 8. The head region and in particular the head/shank interface can undergo significant cold work hardening raising the tensile strength in these regions considerably in excess of the 1000 MPa [4] specified. At these high strength levels, subsequent electroplating brings a serious risk of hydrogen embrittlement. The deformed microstructure which resulted from the manufacturing process, highly distorted and having high concentration of lattice defects like vacancies and dislocations, favours the diffusion and concentration of the hydrogen released during electroplating.

**Fig. 8.** Bolts cross section macrostructure showing the deformation lines produced by head forging due to non-uniform deformation

The solubility of hydrogen decreases with temperature and hydrogen accumulated in lattice defects may precipitate in gaseous form, originating a pressure high enough to produce small cracks. This can however be avoided by a post plating baking treatment to remove hydrogen prior to service [3,4]. Zinc electroplated components must undergo the treatment at temperatures around 200°C, for several hours and immediately or shortly after plating.

more gas evolution during plating or to thicker and less permeable coatings. To prevent risk of failure due to improper baking after electroplating, standardized tests on samples may be conducted [7,8]. Another alternative is to choose a coating procedure without hydrogen embrittlement risk.
