IMPACTS OF THE STORM *HERCULES* IN PORTUGAL

Abstract –The aim of this study is to analyse the impacts of the *Hercules* storm in Portugal. The storm occurred from January 5th to 7th, 2014. A brief characterization of the storm was conducted and the witnesses' accounts were compiled, complemented with field survey before and after the storm. The results show that this event had origin in a strong system of low pressure that hit Portugal. The system triggered strong sea waves with long periods, run-ups between 6 to 9 m, and inundation depths mostly under 1 m. The effects on the Portuguese coastline showed some weaknesses in the spatial planning management: (i) the fact that a wave train restricted to the beaches, front streets, ports and marinas caused significant damage; (ii) some people ignored the emergency management authorities, putting themselves in a risk situation.

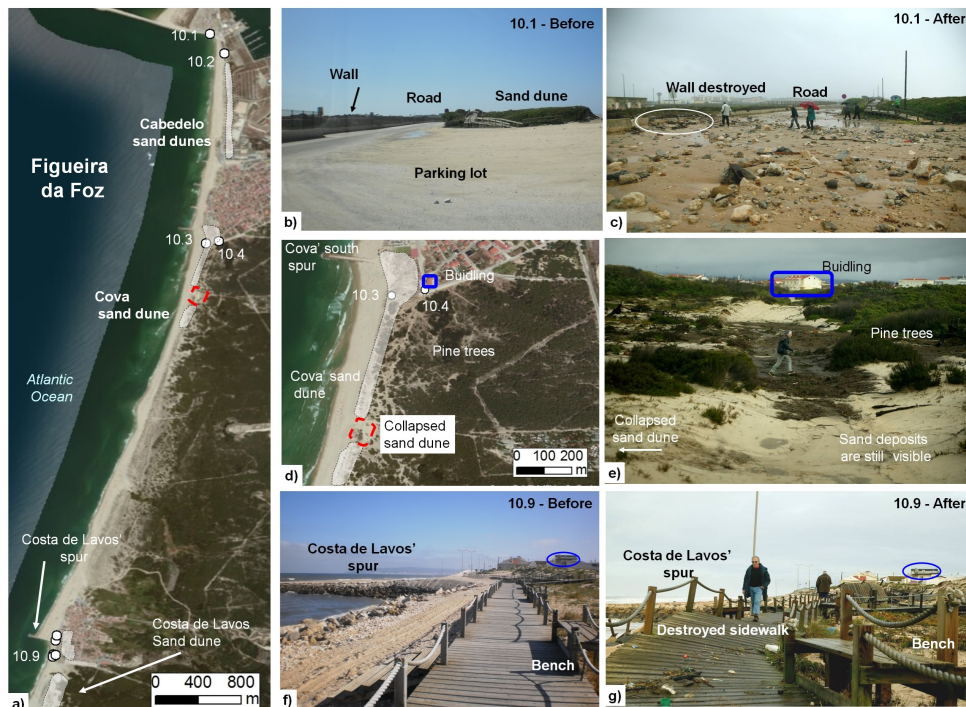
A field survey had been conducted at *Cabedelo*, *Figueira da Foz* (Point 10.1) before this storm on April 18th, 2012 (fig. 5b and SM 3b). Photos after the storm show that the waves overtopped the parking lot which is 5.67 m high (table SM I), inundating it and depositing sand and small boulders. It partially destroyed a wall near the road. The sand dune is 9.13 m high (point 10.2), and did not suffer significant damage.

The *Cova*' sand dune showed to be a natural barrier (fig. SM 3d, Point 10.3), reaching a height of 13.84 m. In 2013 part of the sand dune was showing signs of collapsing (fig. SM 2) being almost as the same level as Point 10.4 (5.10m). Although there were no structural damages on the area, the collapsed sand dune allowed the water to penetrate inland till the pine trees (fig. 5d, e).

The field survey conducted on *Costa de Lavos* on June 13th, 2013 shows that the sea front of *Costa de Lavos* (fig. 5f, Point 10.9) is located on high ground at 10.91 m, as is the south spur (Point 10.6, is 9.13 m). The storm did not damage any building or important infrastructure, but it completely destroyed the wooden sidewalk (figs. 5g and SM 3e) which is between 7.34 m and 8.77 m high (Points 10.7-9).

Fig 5 – Field survey conducted at *Figueira da Foz*: a) Framework; b) and c) Point 10.1 before and after the storm; d) Zoom of *Cova* sand dune; e) *Cova* sand dune photo;

f) and g) Point 10.9 before and after the storm. c, d, g: Photos taken by Pedro A. Cruz.
Fig 5 – Trabalho de campo na Figueira da Foz: a) Enquadramento; b) e c) Ponto 10.1 antes e depois da tempestade; d) Duna da Cova- ampliação de a; e) Fotografia da duna da Cova; f e g) Ponto 10.9 antes e depois da tempestade; c, d, g: Fotografias tiradas por Pedro A. Cruz.

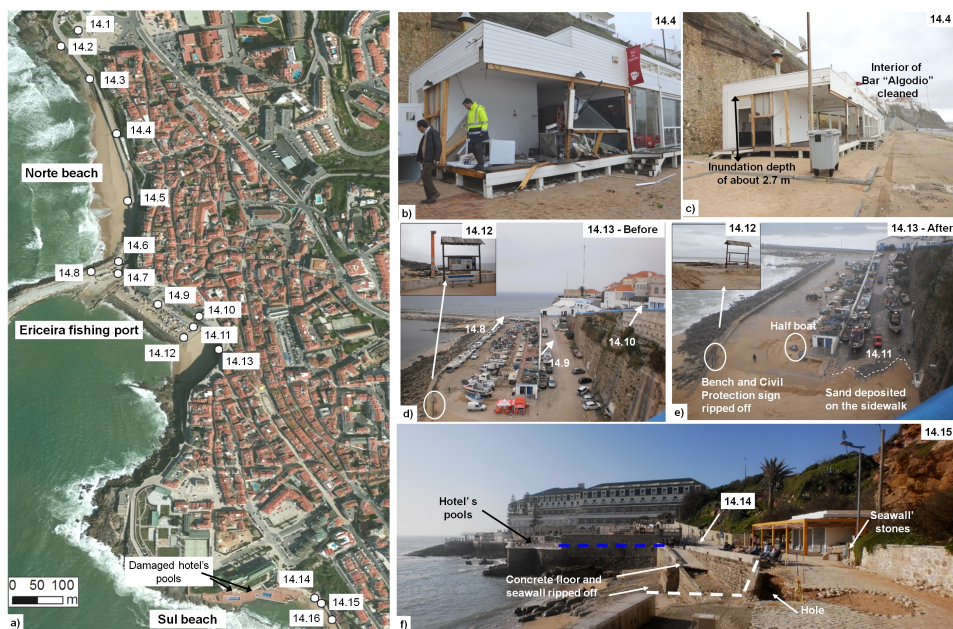
Ericeira (Point 14) was surveyed on several occasions, both before and after the storm. At the *Norte* beach, the sea waves moved several large boulders, caused a landslide and significant destruction on a concrete stair at Point 14.2, located at a height of 8.12 m (fig. SM 4 b, c, d). The waves also ripped away the concrete bricks of the sidewalk (fig. SM 4i), and completely destroyed all the beach bars (figs. 6b, c and SM 4e, f) except one that remained standing. The “Algodio” bar is located about 7 m above mean sea level (Point 14.4). The first author measured an inundation depth of 2.7 m on the bar (fig. 6 c), giving a local run-up of 9.7 m. Furthermore, the waves ripped away about 75 m of the concrete sea wall (fig. SM 4 g), which was deposited on the road. The cleaning operations started on January 7th and about 2 months later, on March 8th the road was clear of the debris (fig. SM 4 h). The beach was about 5 m high before the storm. However, figure SM 4j shows the erosion of the beach close to 2 m, and the access to the beach (Point 14.5) could not be used.

From the *Norte* beach, the waves propagated into the *Ericeira* fishing port. The naval club, located at a height of 5.19 m (Point 14.6), was completely destroyed (fig. SM 5 b, c), and on March 4th 2014 it was completely renovated (fig. SM 5 d). Two men trapped inside the club said the water level reached their necks (table I). The breakwater is 6.57 m high (Point 14.8), and the witnesses also reported that the waves passed over it. The difference in heights is 1.38 m which confirms the witnesses' accounts. On the other hand, photos taken during the storm (fig. SM 5 e) and in the evening of January 7th (fig. SM 5 f) show the waves hitting the breakwater and passing over it, validating the reports (table I). In addition, photos taken before and after the storm at the fishing port (fig. 6 d, e) showed a significant deposition of sand (fig. SM 5 g) that most likely originated from the *Norte* beach. The maximum inundation level was 4.51 m (Point 14.11) whereas the ground has a height of 3.9 m (Point 14.12), which shows that the breakwater had an important role in decreasing the waves' impact on the fishing port because the inundation depth was 0.61 m only. Since the fishermen's warehouses are located on elevated ground (fig. SM 5 h) the waves did not cause significant damage inside the facilities, but the wave currents were strong enough to destroy several vessels, and ripping away a bench and the civil protection sign (fig. 6 e).

Fig. 6 – Field survey at *Ericeira*: a) Framework; b) Algodio bar destroyed; c) Bar and road cleaned from debris; d) and e) Point 14.13 before and after the storm; f) Damage at *Sul* beach.

The *Sul* beach also suffered significant damage from the waves that ripped away the concrete floor and seawall, scattering debris and stones and leaving a hole on the ground (fig. SM 6 f and 6 b, f, g). Although by March 7th the sand and debris had been cleared from the sidewalk (fig. SM 6 c), damage was still visible. The waves hit the sidewalk, breaking and increasing significantly in height (fig. SM 6 d). Photos taken after the storm showed sand deposited on the sidewalk and broken windows in a restaurant (fig. SM 6 d, e). The sidewalk is located at about 6 m high (Point 14.14, Point 14.15, and Point 14.16); the windows are located about 2 m above the ground, giving a run-up of more than 6 m. The swimming pools of the hotel, at the same level as the sidewalk, were also very damaged (fig. SM 6 h). In addition, a fishing vessel was recovered from the sea. It was found around 8 m deep, about 2 km south of *Ericeira* and about 500 m from the beach, as reported by professional divers of NDivers.

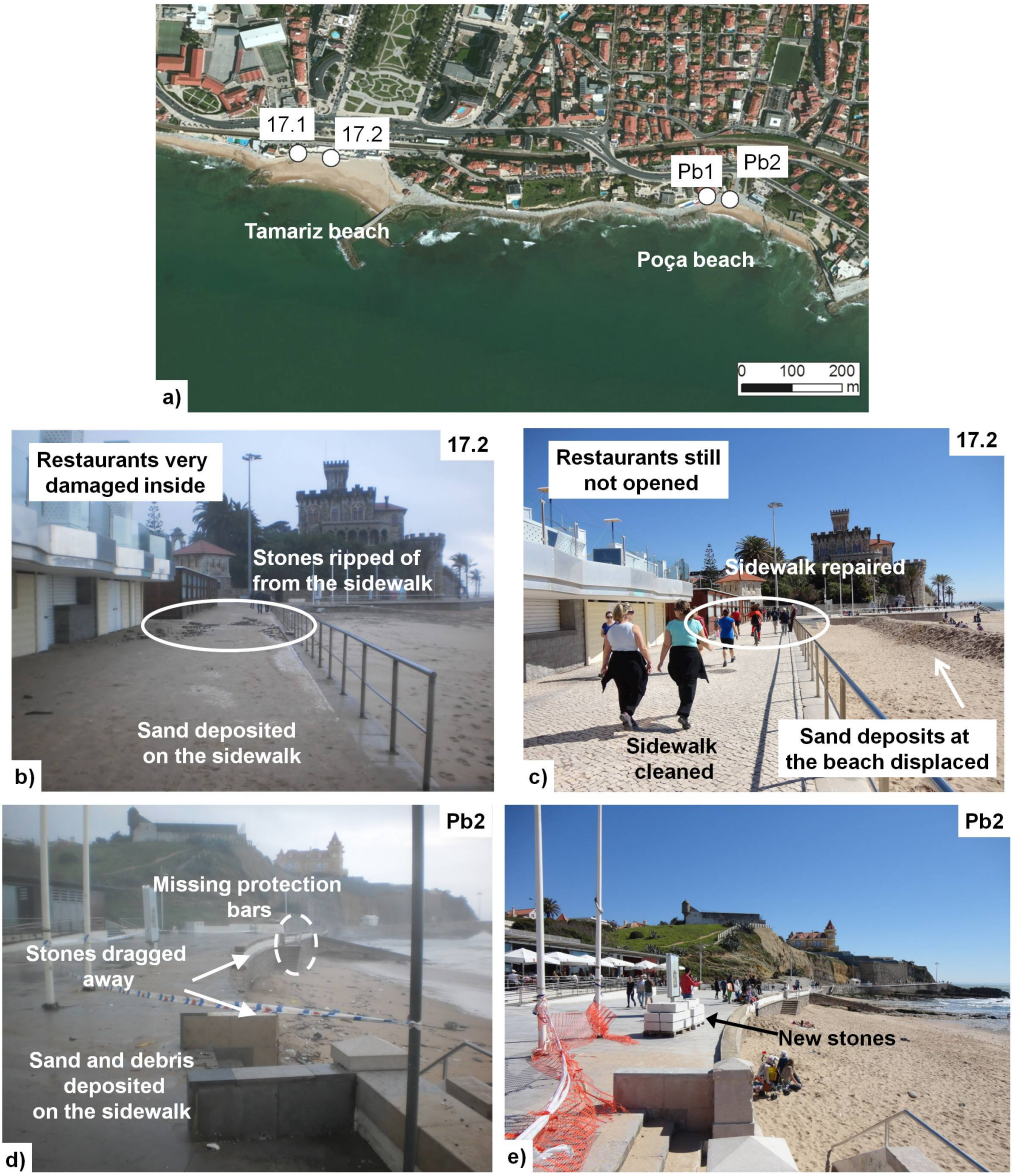
The January 7th survey showed a similar situation at *Tamariz* beach, *Estoril* (Point 17), with sand deposited on the sidewalk and stones ripped away from it (fig. 7 b and SM 7 b). The witnesses and owners of the promenade's restaurants and bars also reported damage (table I). On March 8th, 2014 everything was cleaned and repaired (fig. 7 c and SM 7 c), and one restaurant was already opened for business. Point 17.1 and 17.2 were 5.59 m and 5.00 m high, indicating the waves were at least 5.6 m high.

The media did not report any damage on the *Poça* beach, *Estoril*. Nevertheless, the first author found significant damage (fig. SM 7 d and 7 e). The inundation mark was at 6.12 m (Point Pb1). The sidewalk is 5.40 m high therefore the local inundation depth was 0.72 m, enough to scatter the sea wall stones on the sidewalk. On March 8th, 2014 the protection bars were still missing (fig. SM 7 f), but new stones were already available on site to rebuild the area.

Fig. 7 – Field survey at Estoril: a) Framework; b) Sand deposited on the sidewalk and stones ripped away on Point 17.2; c) Point 17.2 cleaned; d) Damage at the Poça beach; e) New flagstones available.

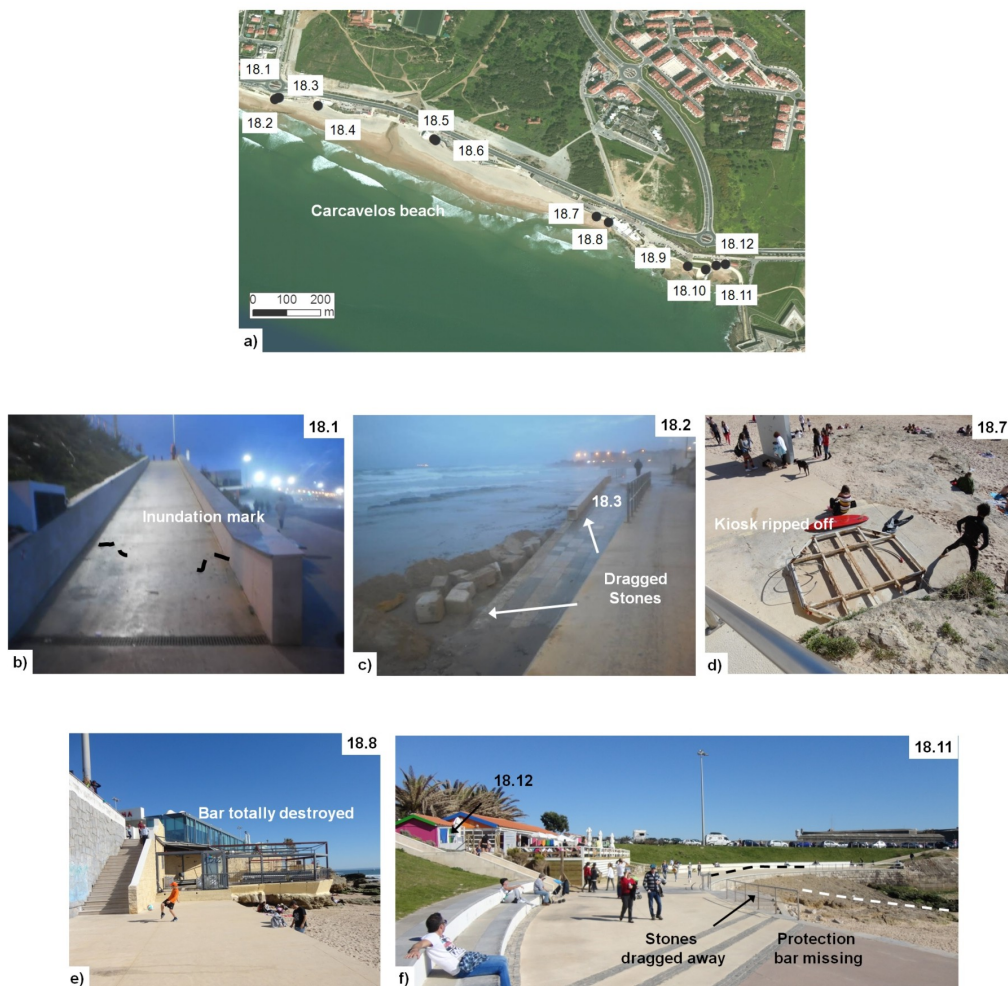
At *Carcavelos* (Point 18), the inundation marks (fig. 8 b) left on the sidewalk showed that the waves reached a maximum of 5.56 m (Point 18.1). The stones were displaced (fig. 8 c,) at a height of 3.85 m (Point 18.3). The bars, restaurants and surf school (Point 18.4), located at a height of 5.35 m, suffered significant damage (fig. SM 8 d); in the same area there was sand erosion on the stairs and sand deposited on the ramp (fig. SM 8 b and c). On March 8th 2014, all shops were opened for business (fig. SM 8 e). The bar "Surf" (Point 18.5) which is located at 6.43 m did not suffer any damage (fig. SM 8 f), and in the evening of January 7th it was opened for business. The sand reached 6.01 m (Point 18.5), showing the waves did not inundate the sidewalk. The most significant damage was observed at the eastern part of *Carcavelos* beach (fig. SM 8 d, e, f, g, h, i): a kiosk was torn apart (Point 18.7), being located at 4.19 m height, as well as the bar "Fizz", located at 4.25 m (Point 18.8). The protection bars were ripped away on several places (Points 18.9, 18.10 and 18.11) showing the waves were higher than 5.40 m. The bar "Moinho" suffered significant damage, despite being located at a height of 6.85 m (Point 18.12). On March 8th it was opened for business.

Fig. 8 – Field survey at Carcavelos beach: a) Framework; b) Inundation mark; c) Stones from the ramp were dragged away; d) Kiosk ripped away; e) Restaurant completely destroyed; f) Point 18.12 shows the maximum inundation area.

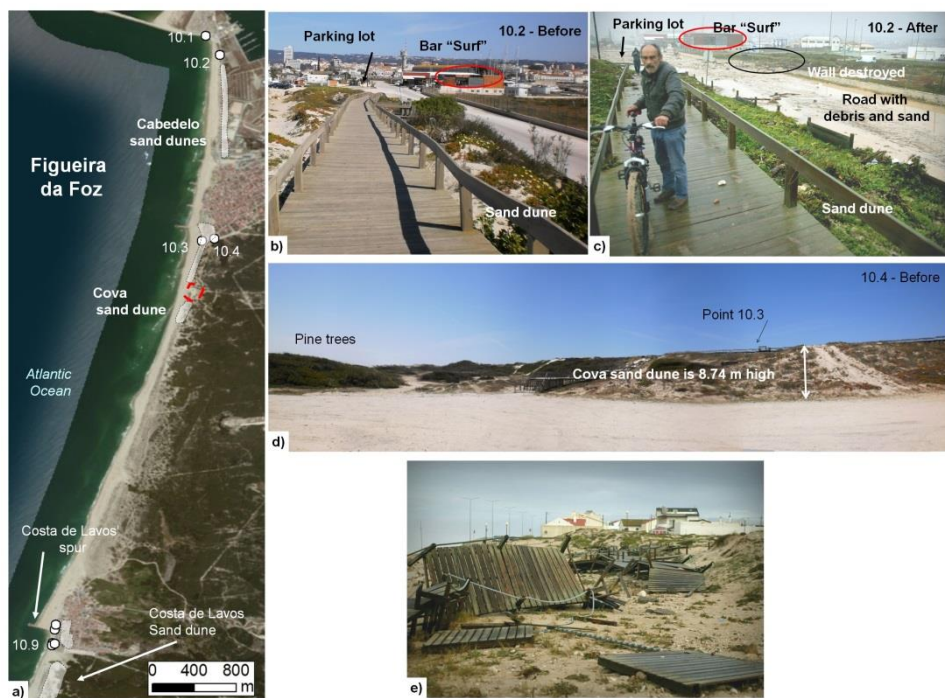
Fig. SM 3 – Field survey at Figueira da Foz: a) Framework; b) Cabedelo sand dune before the storm; c) Cabedelo sand dune after the storm. Photo taken by Pedro A. Cruz; d) Cova sand dune; e) Damage at Costa de Lavos. Photo taken by Pedro A. Cruz.

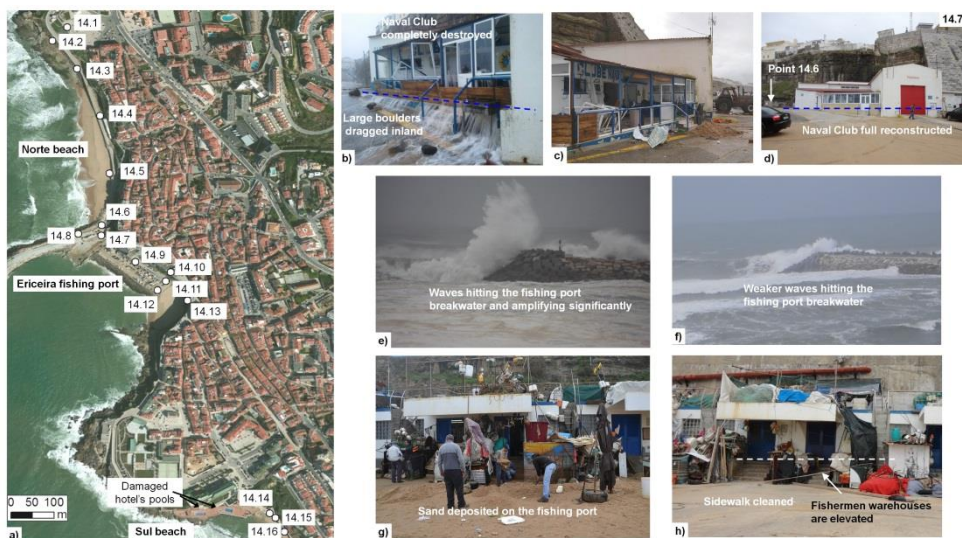
Fig. SM 5 – Field survey at Ericeira fishing port: a) Framework; b) Naval club being inundated. Photo by AZUL; c) Naval club completely destroyed. Photo by AZUL; d) Naval club reconstructed; e) Waves hitting the fishing port breakwater. Photo by AZUL; f) Weaker waves hitting the fishing port breakwater; g) cleaning operations at the fishing port. Photo by AZUL; h) fishing port cleaned.

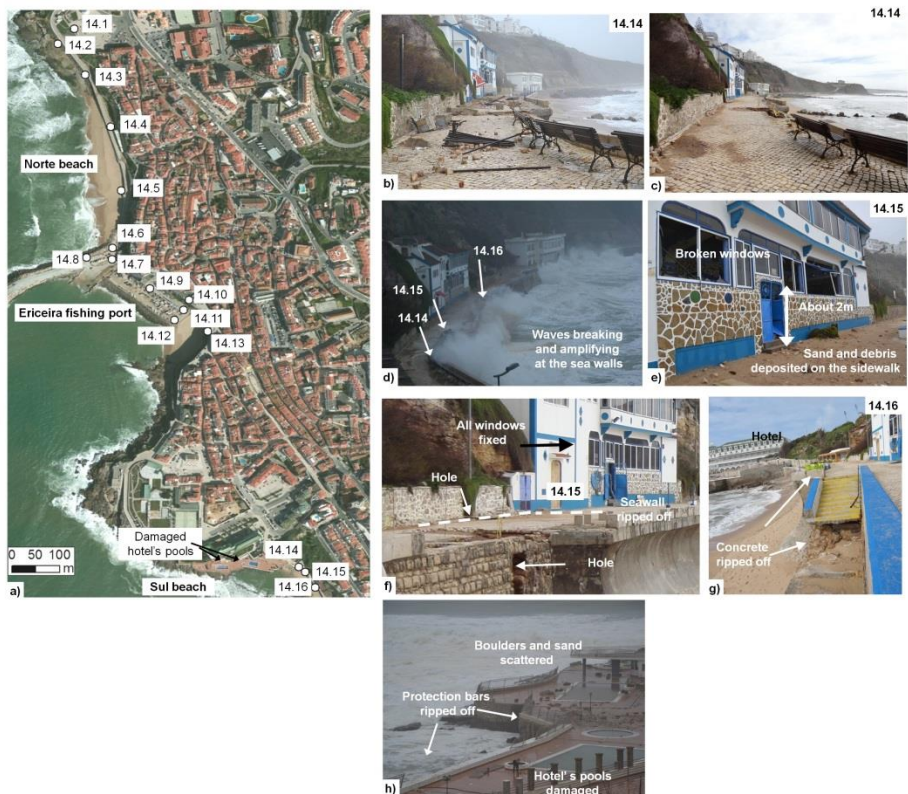
Fig. SM 6 – Field survey at Sul beach, Ericeira: a) Framework; b) damages on the Sul beach sidewalk. Photo by AZUL; c) sidewalk cleaned from debris; d) Sea waves hitting the Sul beach. Photo by AZUL; e) Damage on a restaurant. Photo by AZUL; f) Sea wall ripped off; g) Concrete structures ripped off; h) Damage on the hotel's pools. Photo by AZUL.

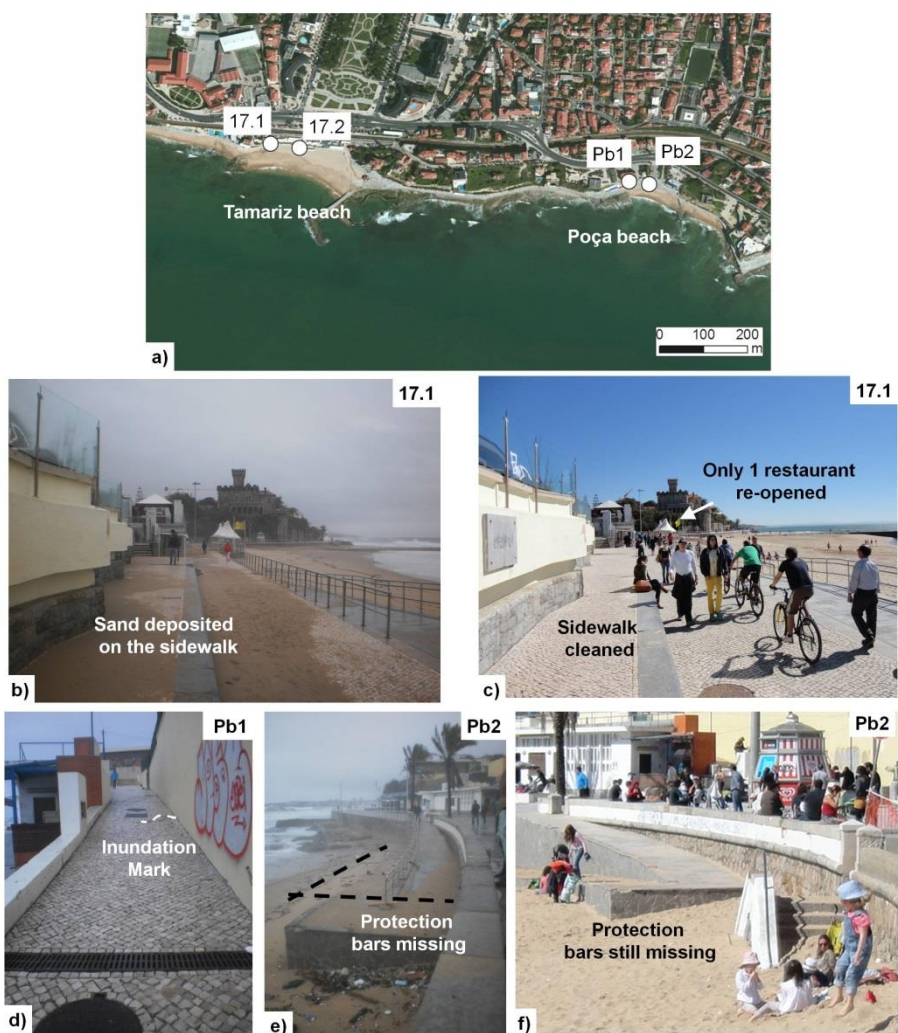
Fig. SM 7 – Field survey at Tamariz and Poça beaches, Estoril: a) Framework; b) Sand deposited on the sidewalk; c) Sidewalk cleaned; d) Inundation mark; e) Protection bars ripped off; f) damage still visible.

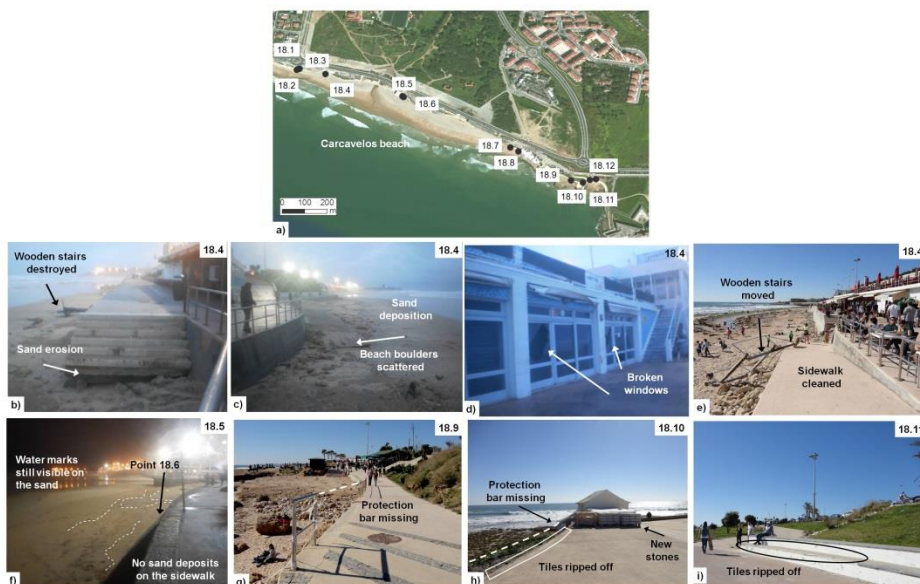
Fig. SM 8 – Field survey at Carcavelos beach: a) Framework; b) Erosion at the base of stairs; c) sand and boulders deposited; d) restaurants damaged; e) sidewalk cleaned, but damage was still visible; f) inundation marks at the beach; g) Protection bars still missing; h) Protection bars still missing and tiles ripped off; i) Tiles of the sidewalk ripped off.
