# CIDADES, Comunidades e Territórios

## **Total heavy prefabrication: Santo António dos Cavaleiros (SAC) and Quinta do Morgado (QM). Overview of the building process, exterior panel pathologies and a study for their rehabilitation**

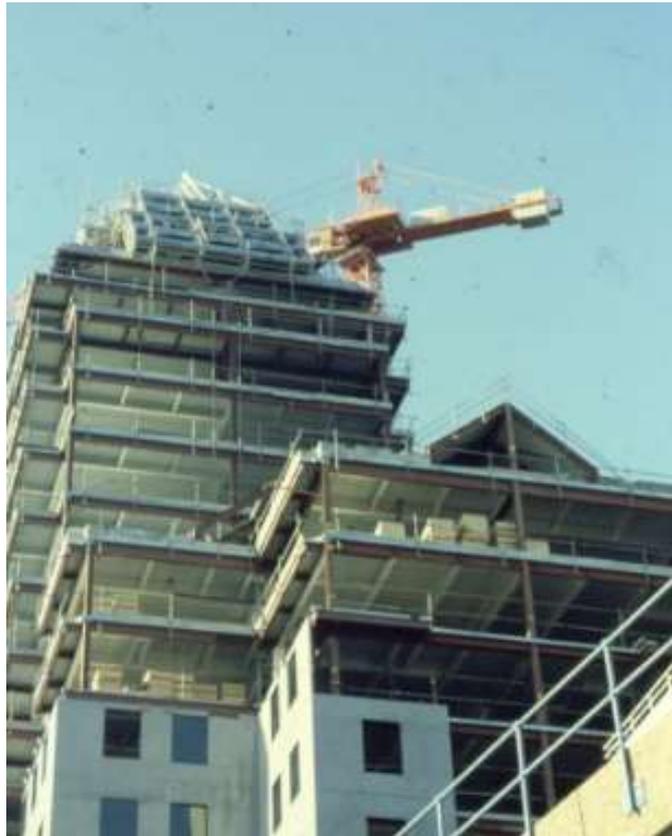
**Figure 2. Partial prefabrication of exterior walls – conventional metallic structure**

Prefabrication, whether total or partial, light or heavy, has been applied in plane, linear, plane-linear and tridimensional ways (Figures 2 and 3).

Partial prefabrication is used, namely the use of façade panels fixed on conventional reinforced concrete or metallic structures.

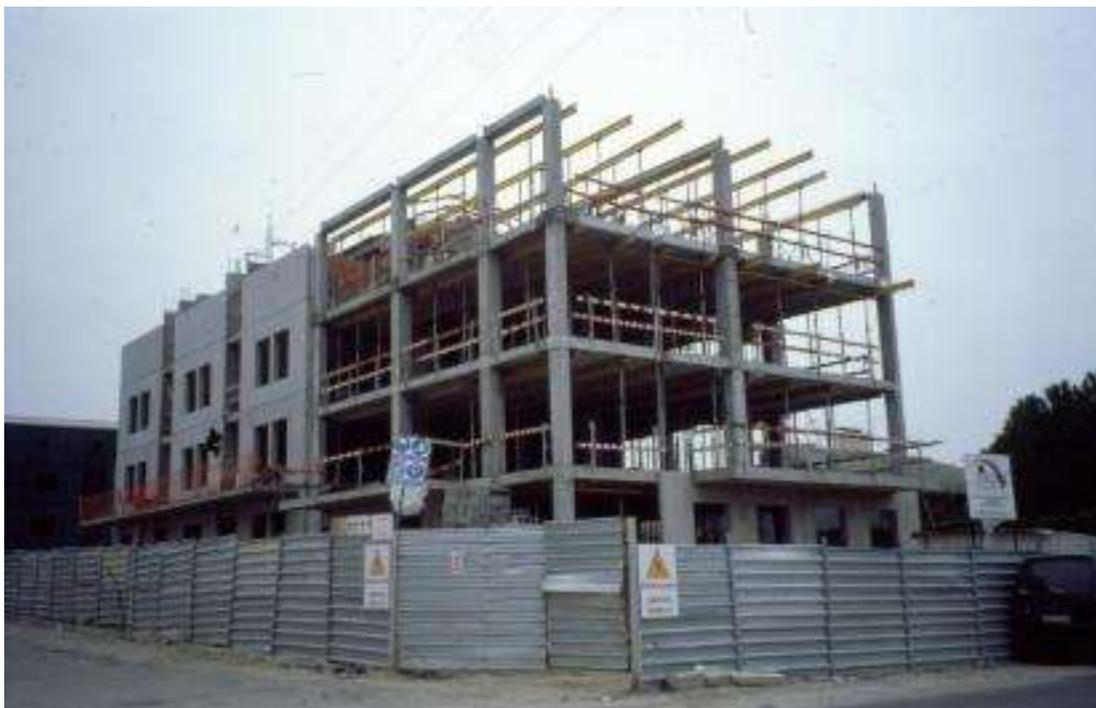
**Figure 3. Plane and Plane – Linear Prefabrication**

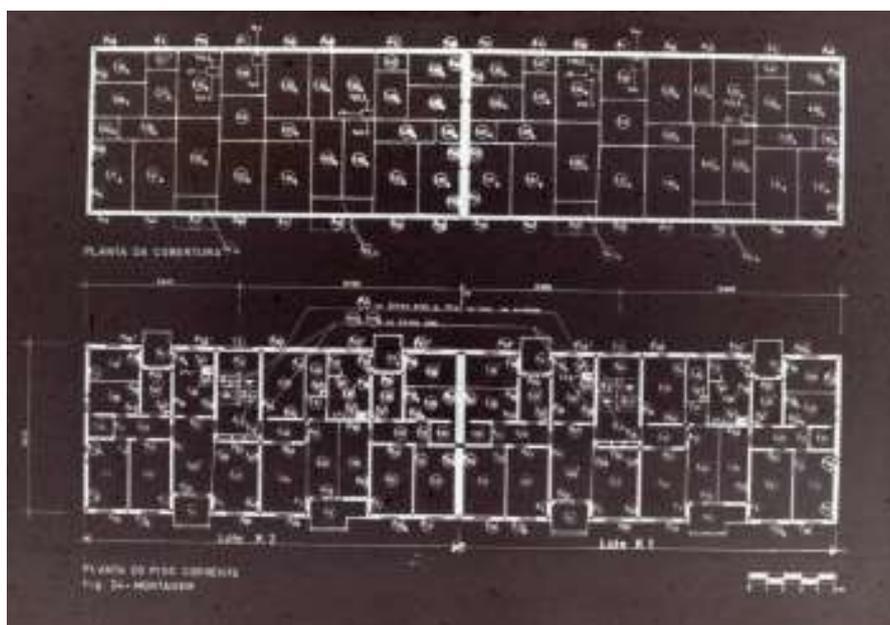
**Figure 8. SAC: Decoupling plans of panels for assembly**

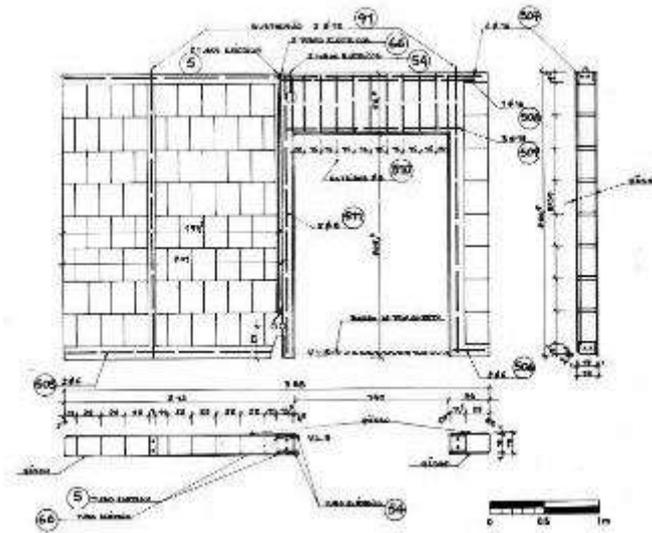
**Figure 11. Resistant Interior panel**

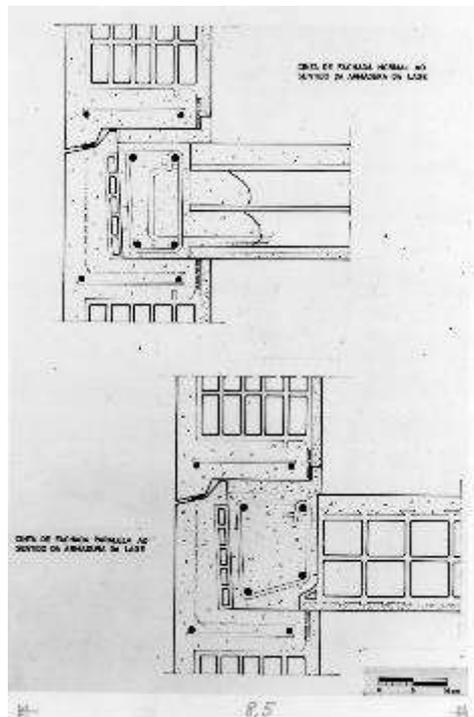
**Figure 12. Junction scheme: Belts and rises in reinforced concrete**

In the construction of buildings, the wall and floor panels are strengthened by a structural network of belts and rises of moulded concrete “in situ” (Figures 12 and 13). The exterior and interior belts differ in their dimensions according to the parallels or perpendiculars and opening floor panels.

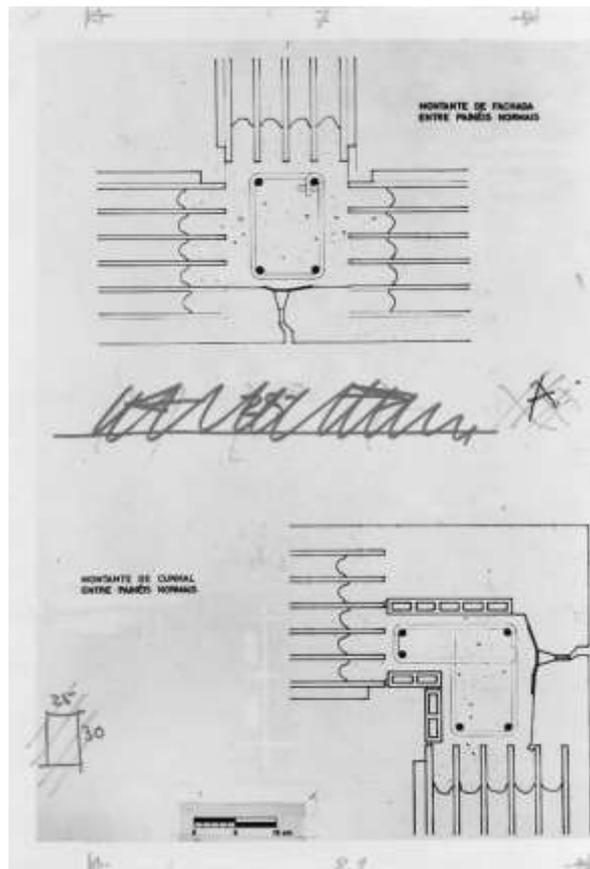
**Figure 13. Junction scheme: Belts and rises in reinforced concrete**

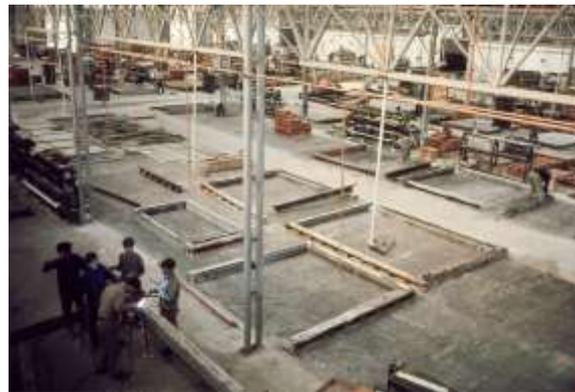
**Figure 16. Factory: General view of the factory – metallic horizontal moulds, and lubrication of the bottom of the mould in order to facilitate demoulding**

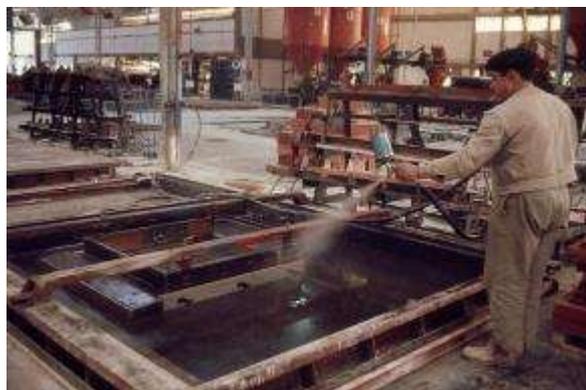
**Figure 17. Factory: General view of the factory – metallic horizontal moulds, and Lubrication of the bottom of the mould in order to facilitate demoulding**

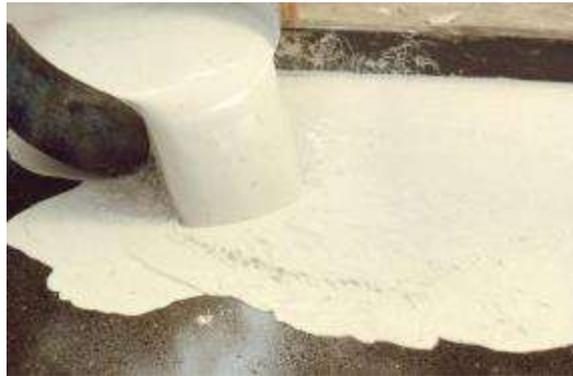
**Figure 18. Gypsum plaster leaking into the mould**

Resistant Interior Panels: the largest number of operations are referred to the manufacture

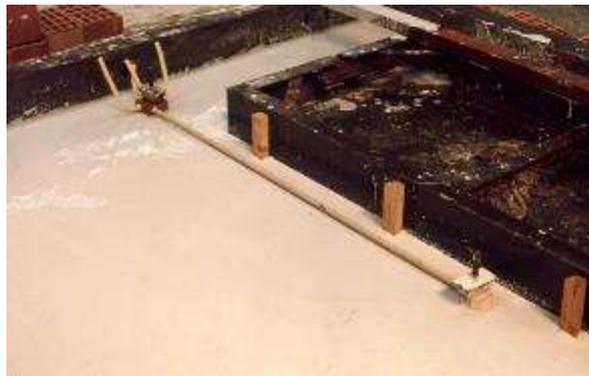
**Figure 19. Gypsum plaster leaking into the mould**

Resistant Interior Panels: the largest number of operations are referred to the manufacture

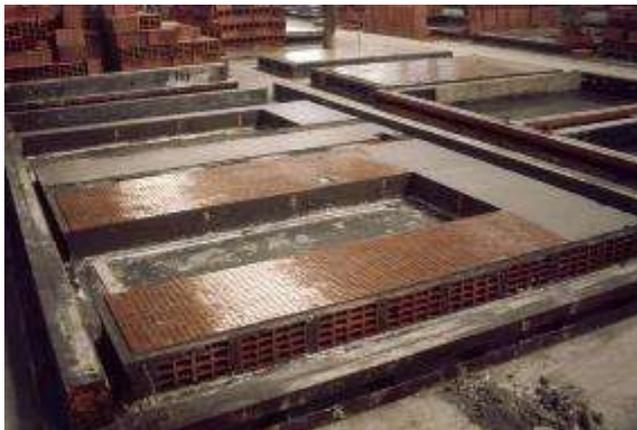
**Figure 22. Resistant interior panels – finishes with ceramic tiles for kitchens**

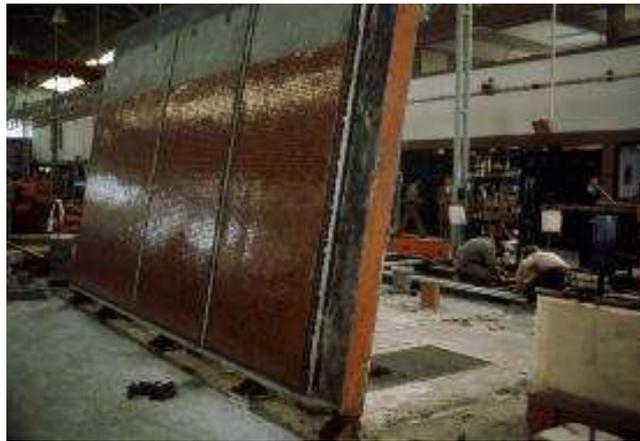
**Figure 25. Hydraulic panel manufacturing mould with a finished partition wall**

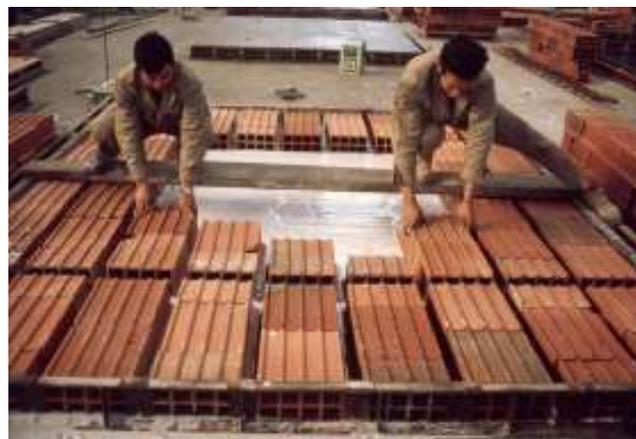
**Figure 26. Slab panels and concrete vibration at reinforcement ribs**

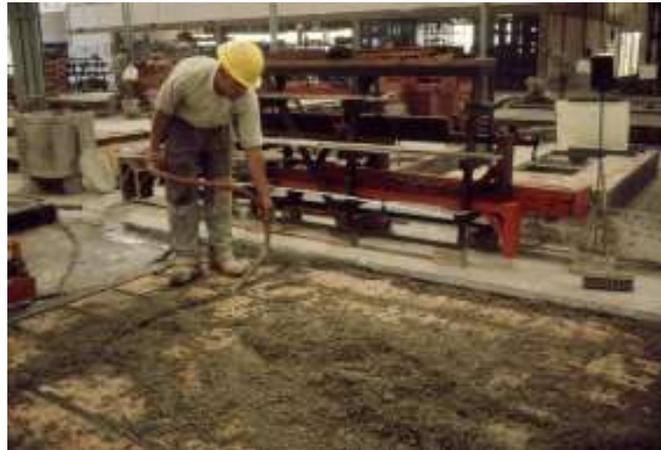
**Figure 27. Slab panels and concrete vibration at reinforcement ribs**

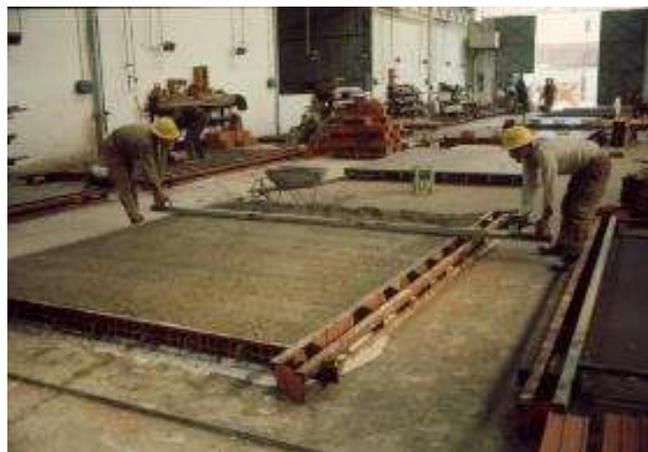
**Figure 28. Regularisation of the concrete layer of the slab panel**

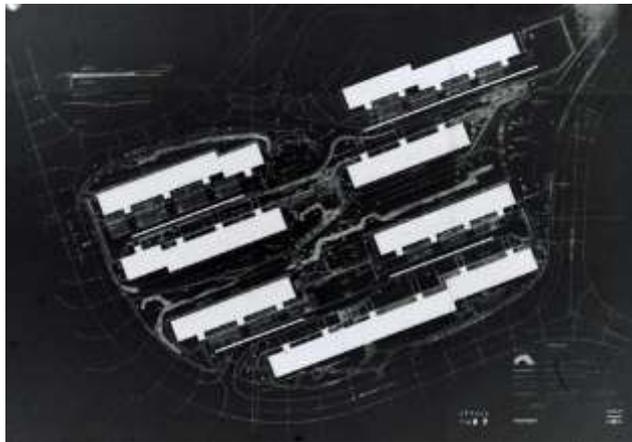
**Figure 35. Layout in which the bands of buildings are parallel and spaced equally to allow assembly with the same crane on a single trajectory**

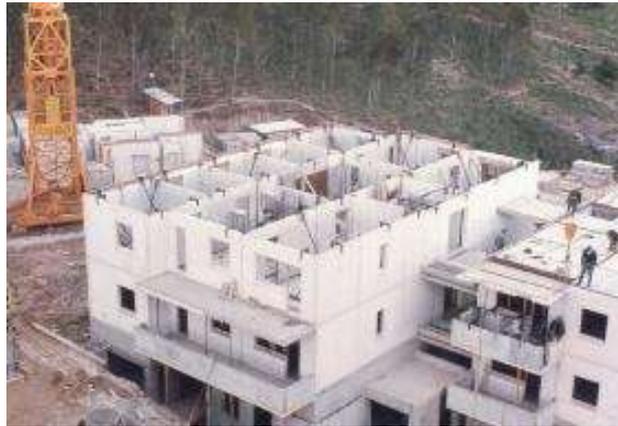
**Figure 43. Assembly of the panels on site**

Network of electric tubes in the reinforced concrete belts, in the panels connections area (previous to the concreting phase)

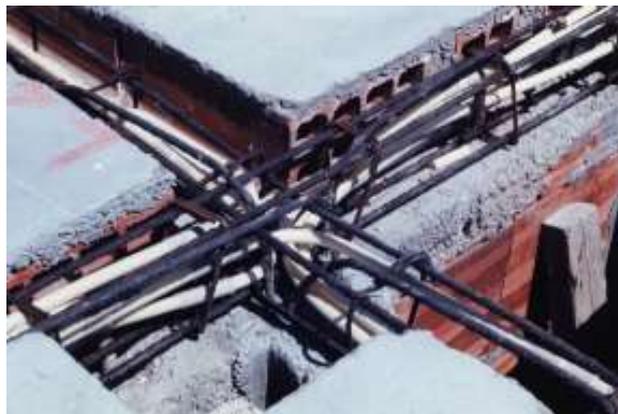
**Figure 44. Assembly of the panels on site**

Network of electric tubes in the reinforced concrete belts, in the panels connections area (previous to the concreting phase)

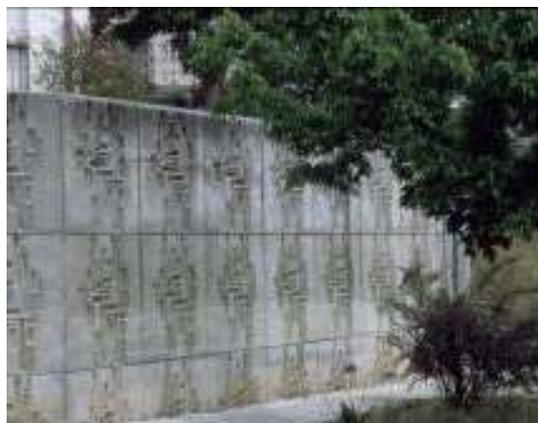
**Figure 51. Retaining wall with prefabricated panels of moulded concrete**

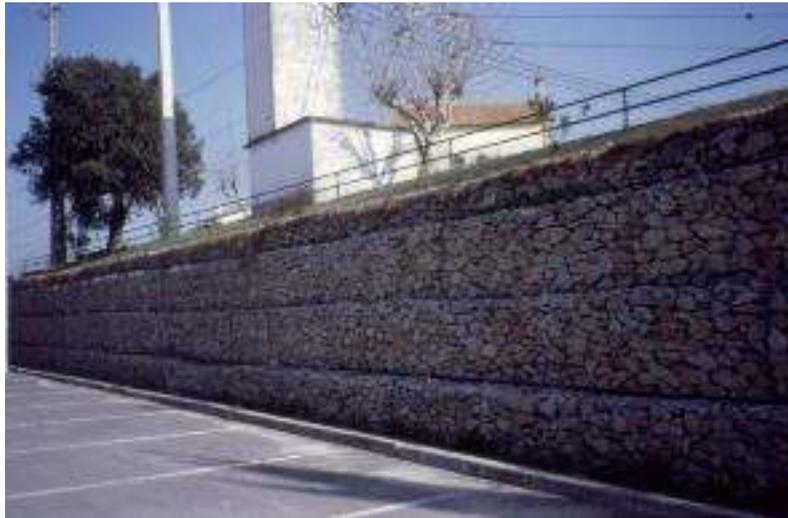
**Figure 52. Gabion retaining wall**

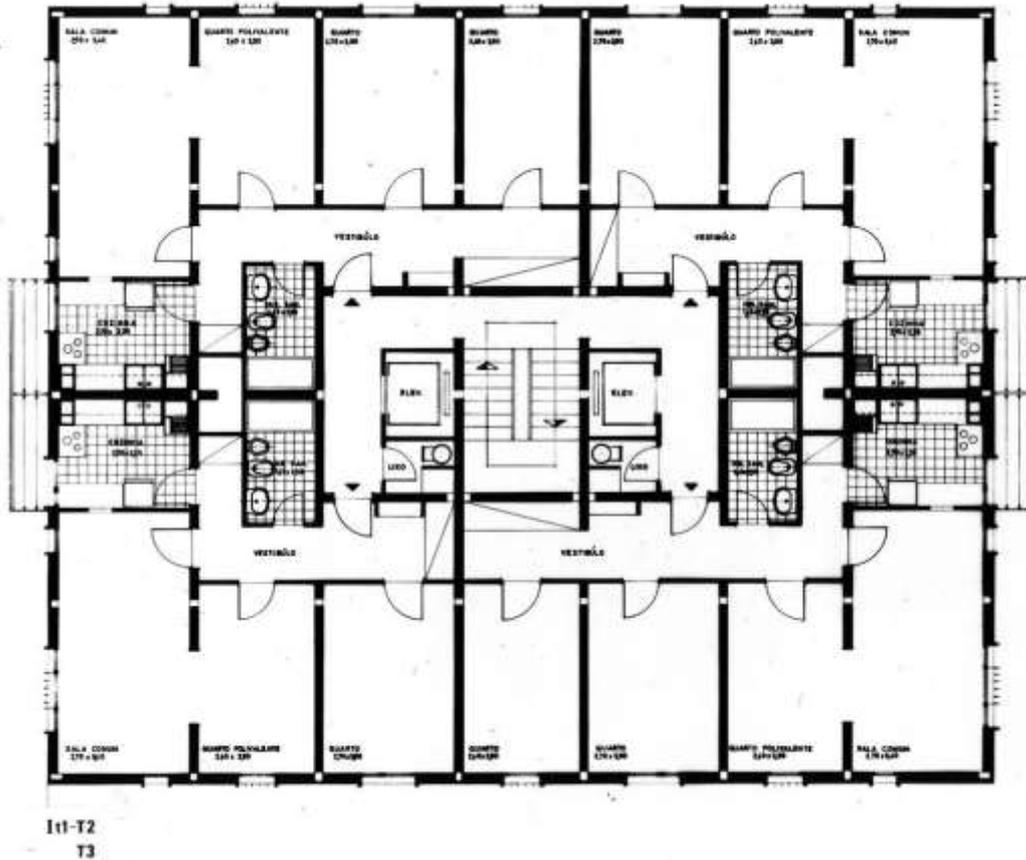
Figure 55. Quinta do Morgado: tower plans

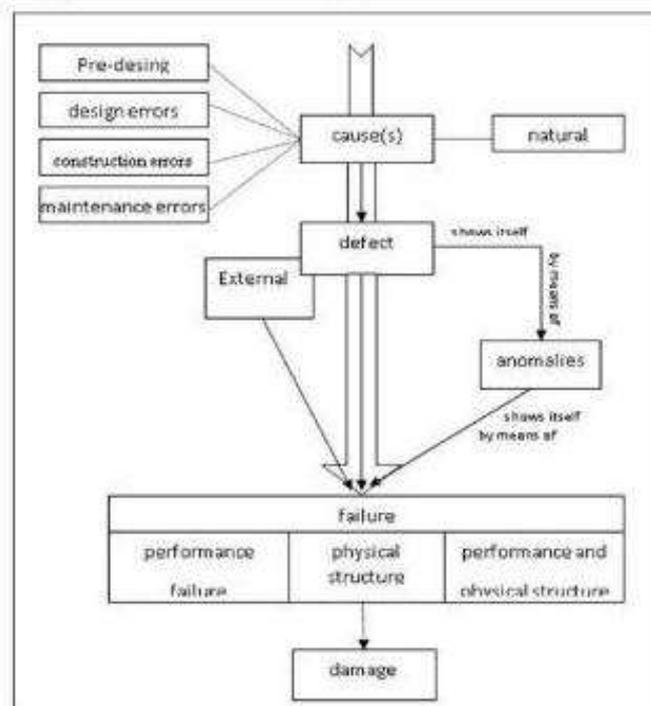
**Figure 58. The decay process**

Diagnosis, which is a fundamental part of the building pathology discipline, demands knowledge of the decay process supported by the building components. On the one hand, the pathological decay may begin with one or more errors which might have been committed during different stages of the building process or, on the other hand, errors committed during design or construction. These defects can either remain in a latent form, or manifest themselves by the action of external agents. Interaction between external agents and defects is the necessary condition for the manifestation of the decay as a failure (CIB, 1993), as shown in Figure 58.

The decay process needs time to develop and it does not immediately cause components to pass from a performance to a failure condition. This is highly relevant to the possibility of planning maintenance strategies with a preventive purpose.

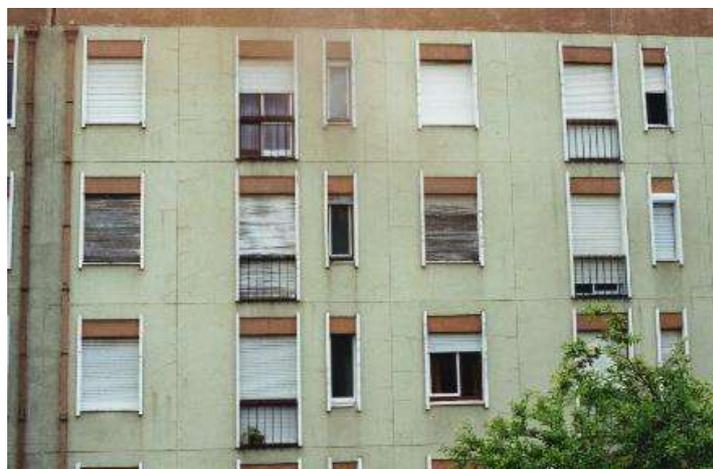
**Figure 59. SAC: fissures detected in the external surface of the outside panels**

- Microfissures due to concrete retraction.

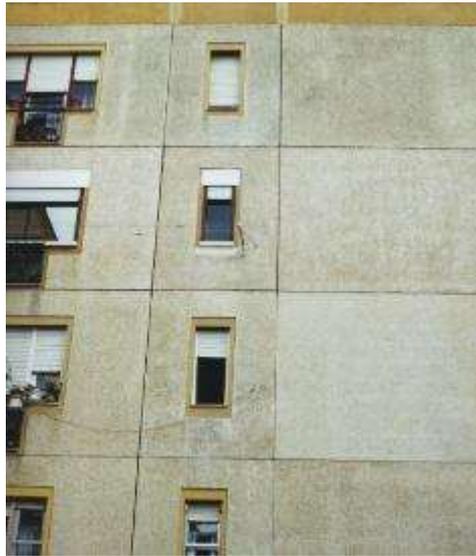
**Figure 60. SAC: Micro-fissures in exterior panels**

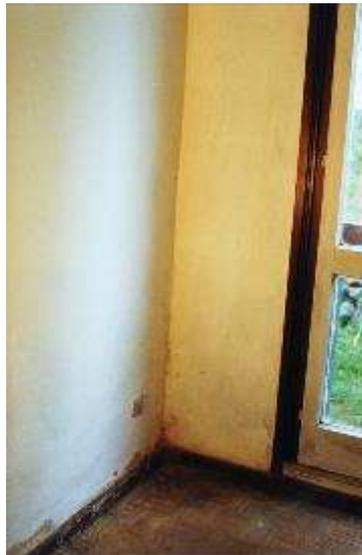
**Figure 61. QM: Interior humidity coming from exterior panels, caused by the incorrect assembly of the panels or by the lack of compression in the sealants of the panels' joints**

- Deficient assembly of panels, which even when they are well aligned, can result in irregular joints (non-parallel) and out of line with the determined tolerance, permitting the entrance of humidity.

- Deficient execution of the joints linking two panels in the mounting when the sealing agent has not been compressed correctly. For example, the sealing agent "compriband" only achieved a sealing level when compressed to about 65%. Compression lower than this made the sealing behaviour of this material seriously deficient.

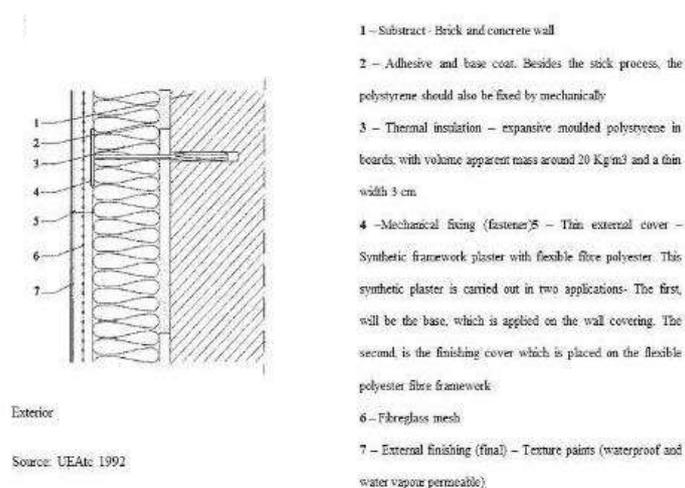
**Figure 62. Summary of the solution developed for the external position of the thermal insulation material on external wall panels**

The proposed solution has the characteristics we now present. This solution is constituted when the thermal insulation material is placed on the outside of the external panel. The mineral reinforced rendering is applied on the thermal insulation. Two layers of synthetic cover with reinforced glass fibre framework or flexible polyester constitutes the "thin" rendering external facing. The texture finishing works are made with cement and resins, with a silicate rendering or with a cover based on EM photo reticulated resins. In the last ten years the appearance and the improvement of these resins has been observed. This resin film hardness and flexibility will be achieved due the solar light influence (CSTB, 1997).

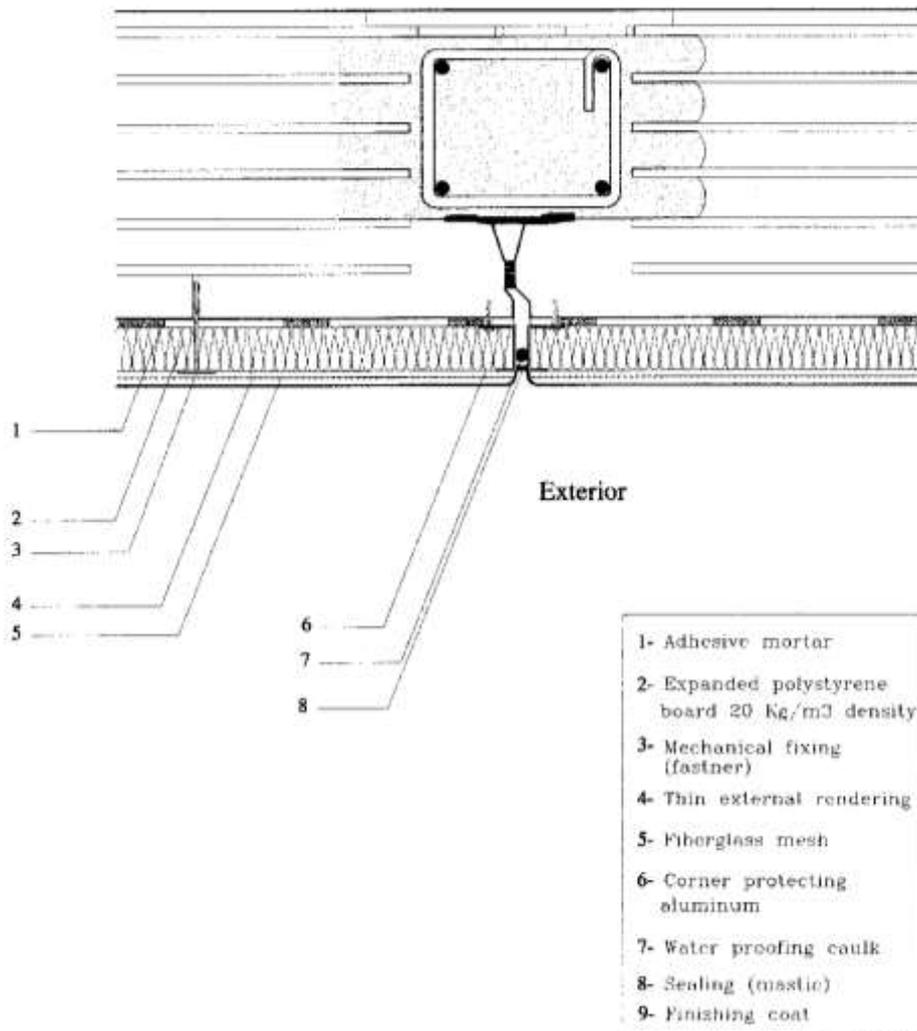
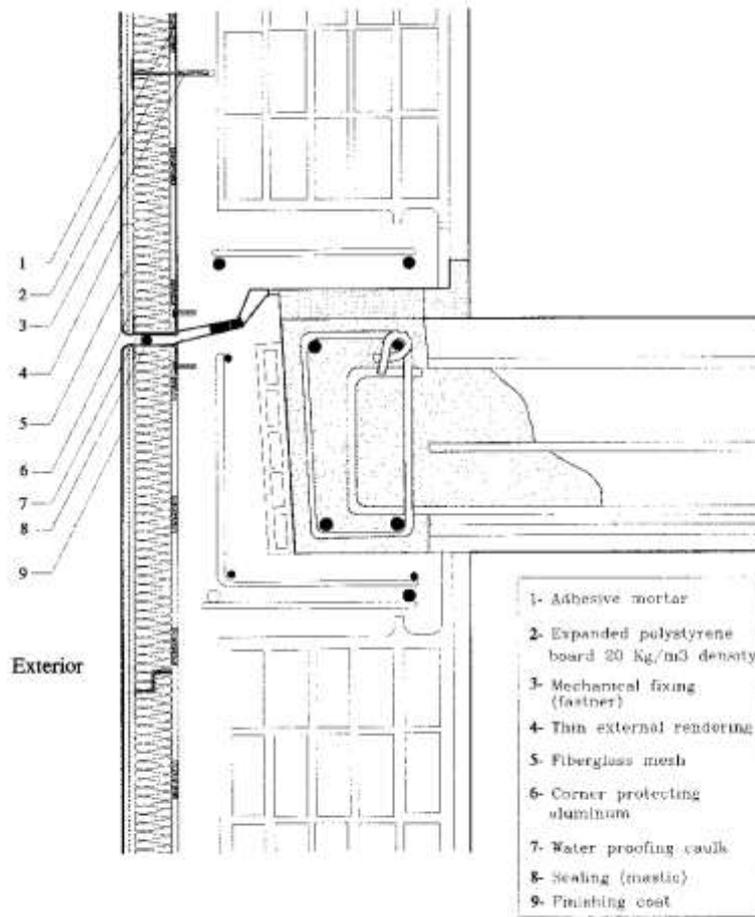
**Figure 63. Rehabilitation of the external walls of the SAC and QM buildings with an external insulation composite system with rendering**

**Figure 64. Rehabilitation of the external walls of the SAC and QM buildings with an external insulation composite system with rendering**

The final solution is presented in figures 63 and 64.

Bearing in mind the above-mentioned opinions and counsel, a final solution is presented, which is adequate to solve the pathologies of the SAC and QM buildings. This solution aims not only at the hygrothermic rehabilitation of the external walls of these buildings and their resultant energy rehabilitation but also the improvement of the global quality of the buildings so as to prolong their lifecycle.

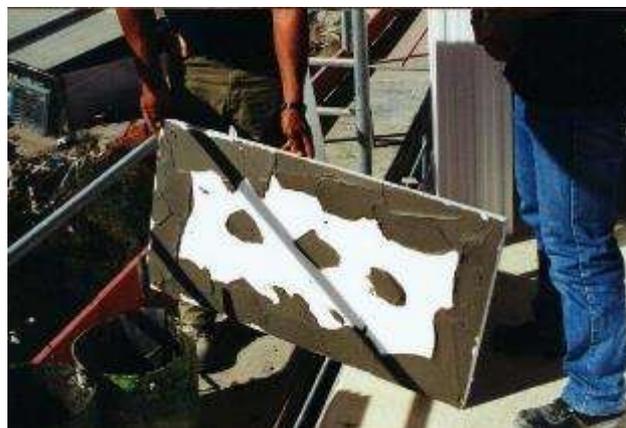
**Figure 65. Building work in progress (Science Faculty of Lisbon Building) – The insulation board with adhesive coat applied with points and bands**

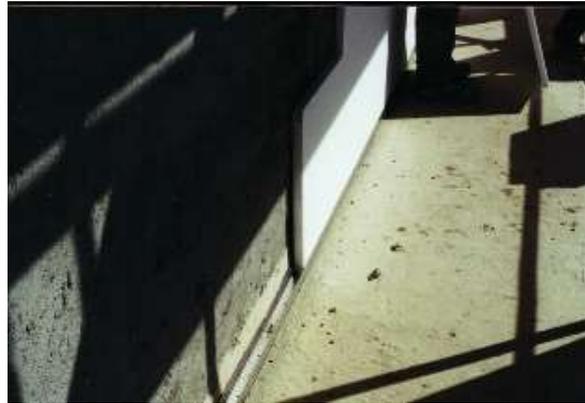
**Figure 66. Building work in progress (Science Faculty of Lisbon Building) – Special fitting profiles to allow an adequate fitting of the pieces and better continuity**
