# PITTING CORROSION OF 304 STAINLESS STEEL IN AN ACTIVATED CARBON FILTER

## CORROSÃO POR PICADA DE UM AÇO INOXIDÁVEL 304 NUM FILTRO DE CARVÃO ACTIVADO

Water leakages of an orange color were found in the cross welding zone and barrel of an activated carbon filter used in a wastewater treatment plant. The analysis of the chloride content in the plant flowsheet showed that the equipment was subjected to unsuited chloride concentration for 304 stainless steel resistance to pitting corrosion. The inside shows holes distributed randomly from about 20 cm above the welding zone to the lower outlet port of the equipment.

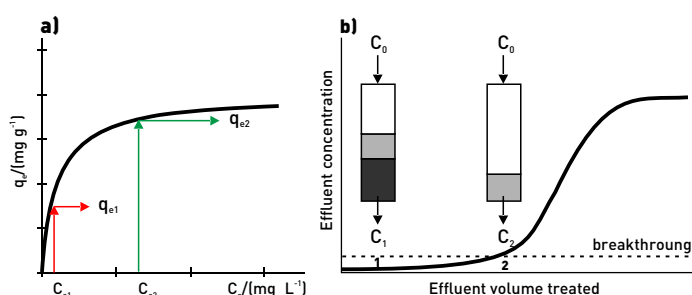
Fig. 4 - a) Isothermal of carbon adsorption; b) Breakthrough curve.

After some time, the loading of the carbon increases, the available adsorption places are filled, and breakthrough of the chloride in the effluent occurs, Fig. 4b). However, there may be chloride transfer from the solid phase to the effluent even when the adsorbent is not saturated. The inverse behavior of the activated carbon is explained by analyzing the equilibrium adsorption isotherm data, Fig. 4a). Indeed, it is only necessary that the input effluent to the adsorption unit has a chloride concentration ( $C_{e1}$ ) smaller than the equilibrium concentration ( $C_{e2}$ ) related with the content accumulated in the adsorbent ( $q_{e2}$ ). In this case it is established a concentration gradient of chloride ion that will impose on the system an evolution for a pseudo equilibrium
