Correlation of ulcerated plaque image with intraoperative findings

Serviço de Angiologia e Cirurgia Vascular do Hospital Divino Espírito Santo, Ponta Delgada, Portugal

Angiol Vasc Surg 2023;19(3):201
DOI: <https://doi.org/10.48750/acv.545>

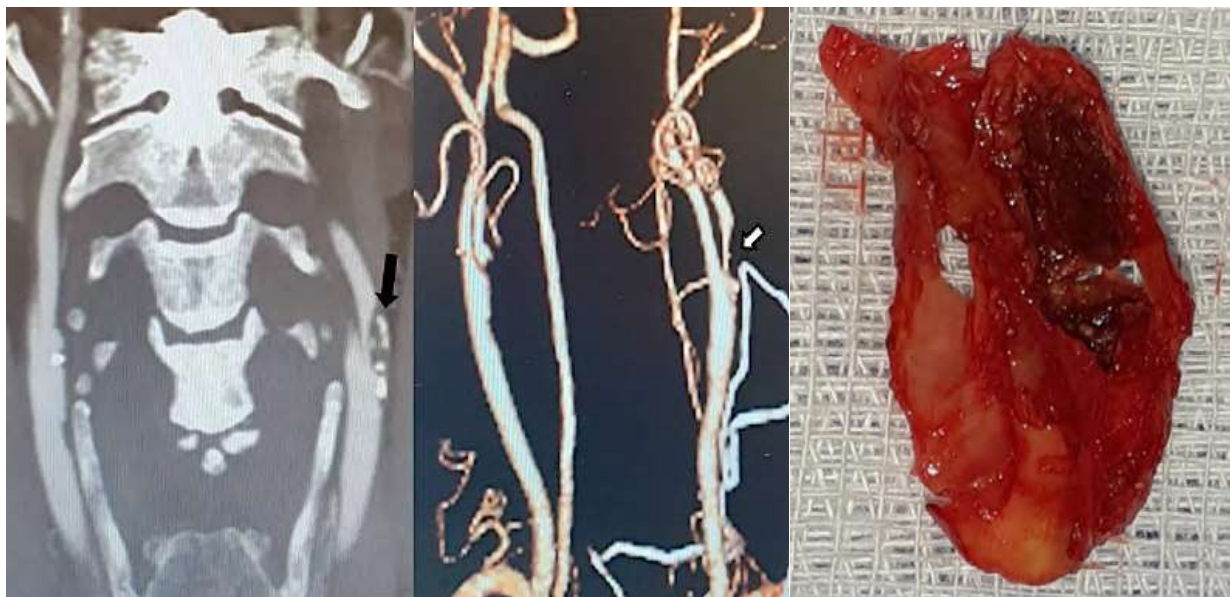
Morphologically, a mixed plaque with a large hypoechoic component was depicted, which was confirmed by Computed Tomography Angiography (left, black arrow). The patient underwent endarterectomy of the carotid bifurcation with Dacron patch closure, with intraoperative confirmation of an ulcerated plaque (right). The patient was discharged on the 8th postoperative day.

Grading of carotid stenosis is the main factor for risk stratification and treatment decision. However, there is increasing evidence that plaque composition and surface morphology play an important role in the outcome of patients. A 74-year-old man with history of coronary artery disease was referred due to a left carotid bruit. The patient referred a previous episode of transient right upper limb sensory and motor loss, less than six months ago. Doppler ultrasound identified a >70% stenosis of the proximal internal carotid artery (ICA) using the North American Symptomatic Carotid Endarterectomy Trial (NASCET) method: Peak Systolic Velocity 240cm/s, End Diastolic Velocity 38cm/s, ICA/common carotid artery ratio 2.6.
